**National Sedimentation Laboratory  
Channel and Watershed Processes Research Unit  
Oxford, Mississippi 38655**

## **Acoustic Imaging of Sediment Impounded by a USDA-NRCS Flood Control Dam, Oklahoma**

**By John A. Dunbar, Peter M. Allen, and Sean J. Bennett**

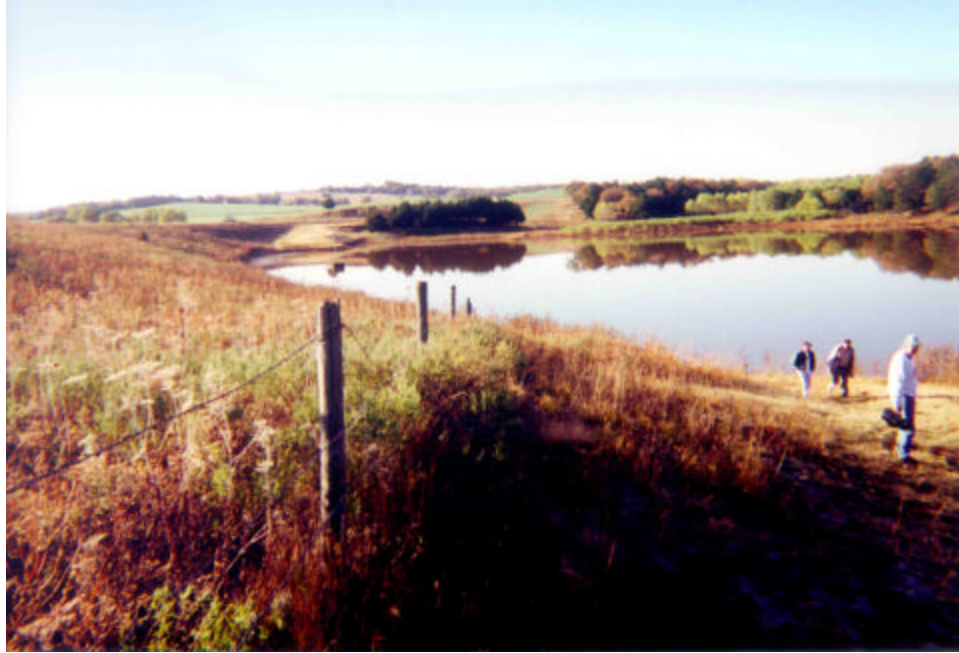
**Figure 2-1. Photograph of Sugar Creek #12 looking directly south showing earthen embankment on left, spillway channel in far distance, and reservoir (November 1999).**

Sugar Creek #12 is located near Hinton, OK, and it is a relatively small lake (19 acres) with a mud bottom and fairly shallow water depths (0.6 to 2 m; Figures 2-1, 2-2, and 2-3). Dam construction was completed on April 6, 1964. This structure has an upstream drainage area of 2,016 acres. The main stream supplying the lake is considered unstable due to the presence of actively migrating knickpoints, and excessive sedimentation rates have significantly decreased storage capacity. No boat ramp is available, and access for small vessels is difficult but tolerable.

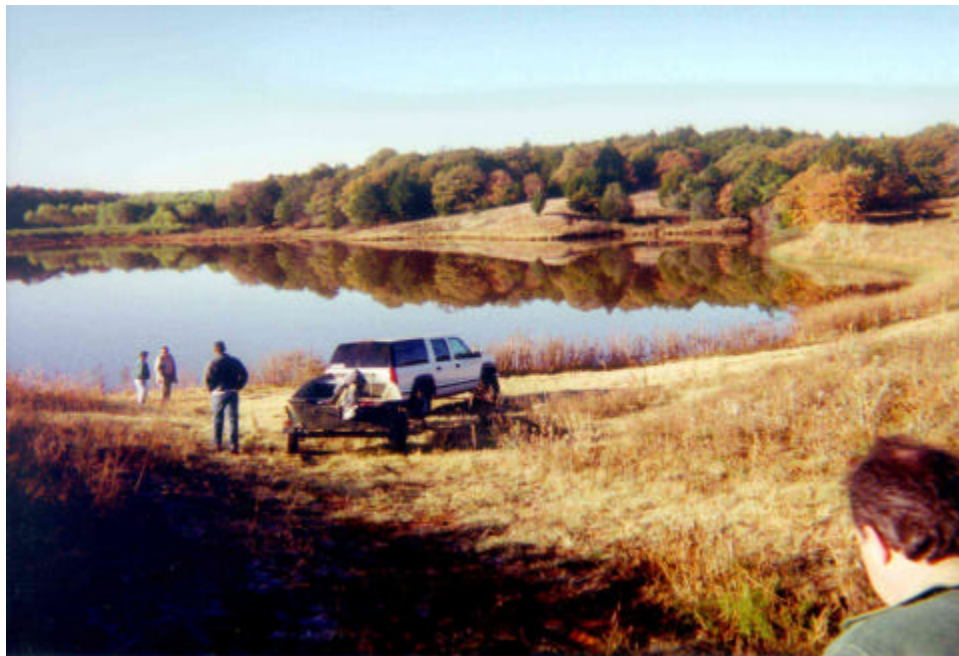
**Figure 2-2. Photograph of Sugar Creek #12 looking toward the southwest showing the reservoir and the main tributary on right (November 1999).**

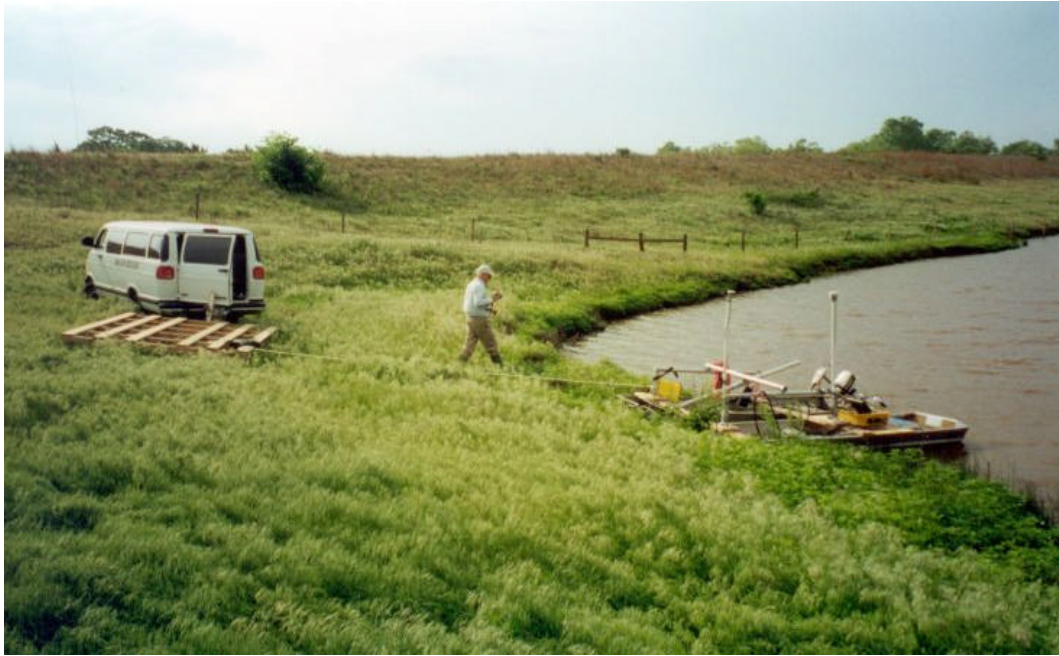
**Figure 4-1. Photograph of Sugar Creek #12 showing the survey vessels (May 2001).**

carried to the shore. A pair of 12-ft Johnboats joined together with an aluminum frame (Figures 4-1 and 4-2) provides a stable platform from which two or three people can work in water depths as little as 6 inches. The boats are powered with a 4 HP outboard motor or an electric trolling motor for low-speed profiling. The sound source is deployed on a mast between the two boats that holds the transducers at a constant depth below the surface and in a fixed position relative to the GPS antenna (Figure 4-2). Control over the transducer location in some fashion similar to this is required to achieve precision water depth information and sub-meter horizontal positioning accuracy.

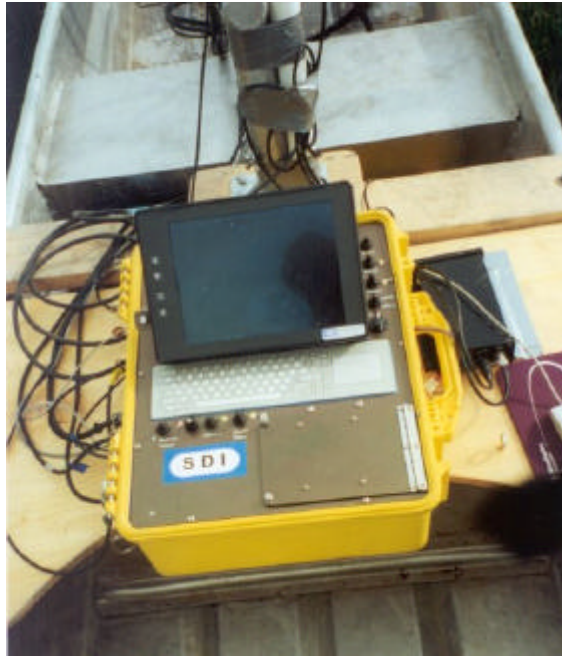
**Figure 4-3. Photograph of acoustic profiling system (May 2001).**

The acoustic profiling system used herein was developed in collaboration between Baylor University and Specialty Devices, Inc. of Plano, TX (SDI; Dunbar, et al., 1999; Figure 4-1 to 4-4). The system was originally intended to be used in sediment surveys of large water supply reservoirs, but the commercialized version has been used to survey lakes, harbors, and rivers as well. The prototype electronics module includes one computer that controls the acoustic profiling, another that controls navigation, a built-in computer monitor, and a differential GPS navigation system. All of these components are contained in one, suitcase-sized water-resistant box. The prototype module weighs 15 kg. In the commercialized version, both subsurface profiling and navigation operations are controlled by a single, faster computer, resulting in an electronics module that is smaller and lighter. Power for the electronics and acoustic source is supplied by a 12 volt marine battery. Depending on the number and type of acoustic transducers used, the sound source may weigh between 25 and 75 kg. Hence, even though the system was designed for large reservoir surveys, deployment in small floodwater retention reservoirs is logistically practical.
